METLAKATLA PENINSULA LEAD-BASED PAINT INVESTIGATION

FOR THE
METLAKATLA INDIAN COMMUNITY
METLAKATLA, ALASKA

**Prepared by
Ridolfi Engineers Inc.
Seattle, Washington**

June 30, 1998

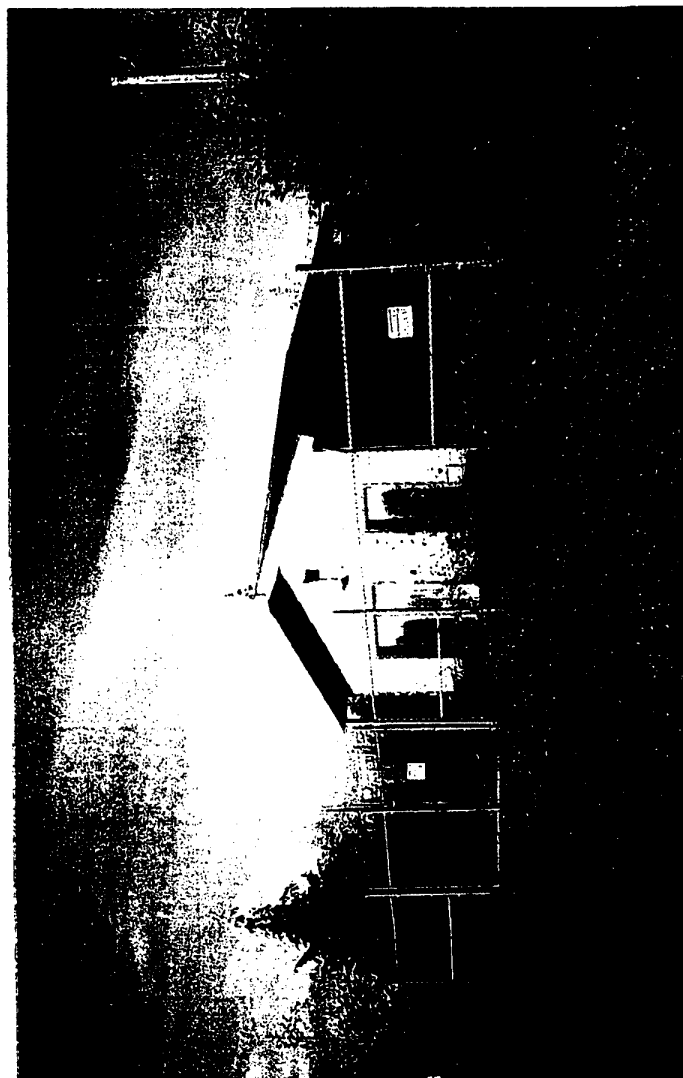
Photograph 14: Chlorination Building

The chlorination building is a 10-foot x 20-foot wood-frame structure within a fenced enclosure (see photograph 14). The building was constructed in the late 1960s as part of the steel water pipeline system that was built by the FAA to replace the DOD water pipeline that served the lower Metlakatla Peninsula. The building contains two water tanks and three types of water lines. The interior is drywall with a concrete floor. The building, fire door, and tanks have been damaged by bullet holes.

Lead-based paint was found in the blue painted surfaces of the tanks and pipelines.

Blue painted surfaces are stable and in good condition. No action is recommended.

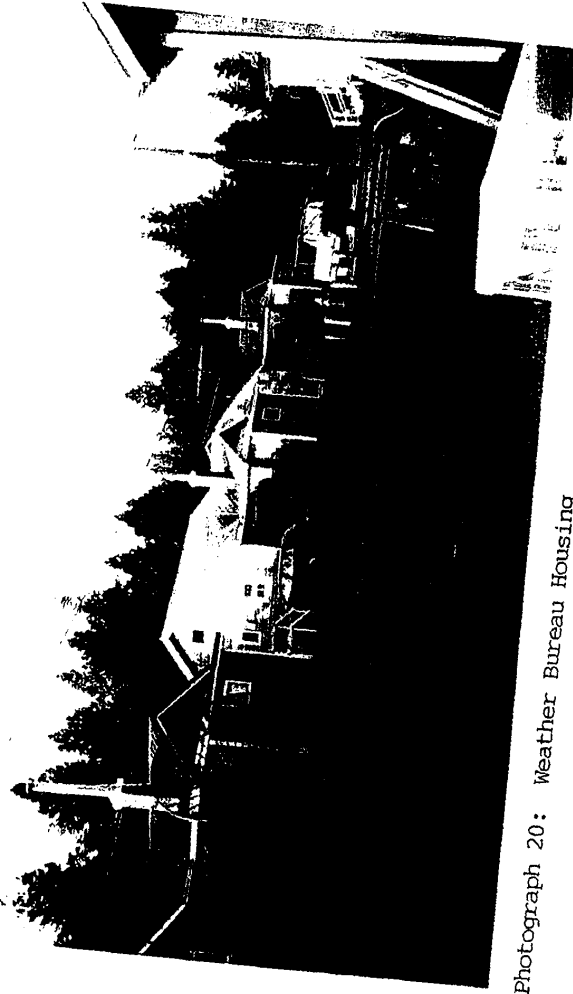
Photograph 20: Weather Bureau Housing

The weather bureau housing consists of seven two-story, wood-frame structures (six residences and one maintenance building) (see photograph 20) constructed in the late 1940s. The buildings have metal roofs and fiberglass insulation. All but two of the houses are occupied full time. One building (B-3) has been condemned for structural reasons; another building (B-6) is used as transient employee housing. An interview with Weather Bureau personnel established that the buildings are all of similar construction and materials. To limit damage to occupied units, suspect LBP samples were taken from the condemned unit.

Remove contaminated soil around all units (see Figure 20-2). Remove soil to depth of 1 foot, to a distance of 15 feet from building. Stockpile excavated soil in designated central location. Perform confirmation sampling of soil to ensure that soil remaining after the remedial action is below the cleanup level for lead. Replace with clean soil and hydroseed. Demolish and dispose of condemned unit after *asbestos abatement*.

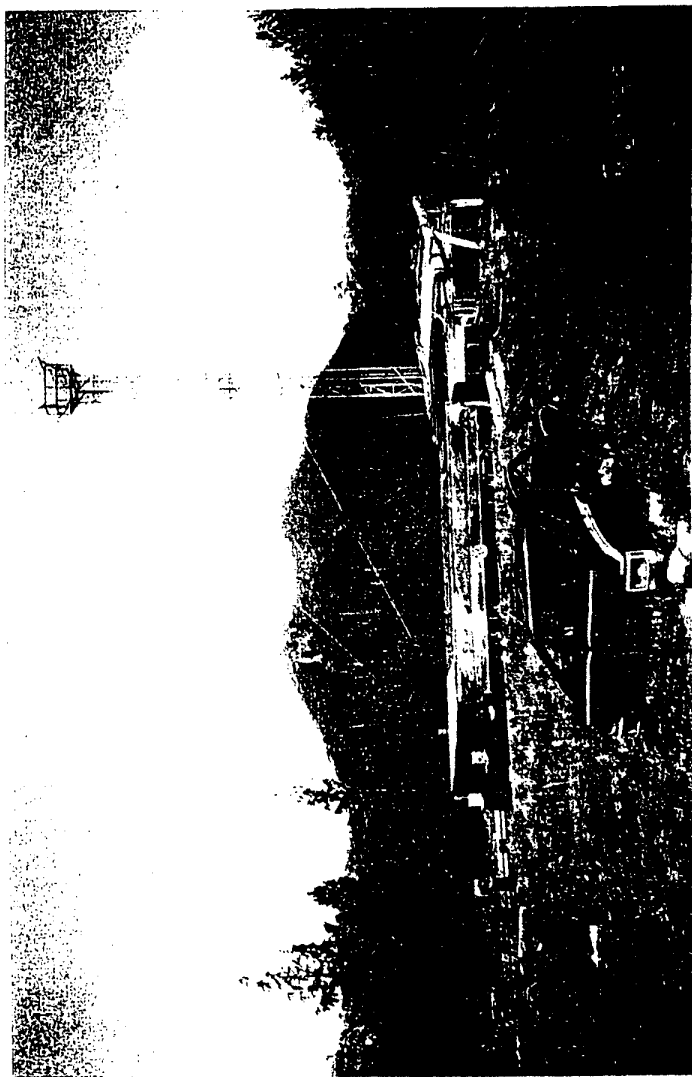
Photograph 22: AACCS Station

The remains of the DOD AACS station consist of a 20-foot x 60-foot wood floor on pilings, a 30-foot faded red-and-white tower (see photograph 22), concrete foundations, concrete pits, and felled wood pole antennas. Abandoned electrical equipment is in the crawl space below the wood floor foundation, and remnants of vinyl tiles are on the wood floor.

Remove and dispose of all painted materials at the site following asbestos abatement (see Figure 22-2). Remove soil to depth of approximately 1 foot, to a distance of 15 feet from building. Remove soil under building area. Remove tower and stockpile for metals salvage. Perform confirmation sampling for soil to ensure that soil remaining after the remedial action is below the cleanup level for lead.

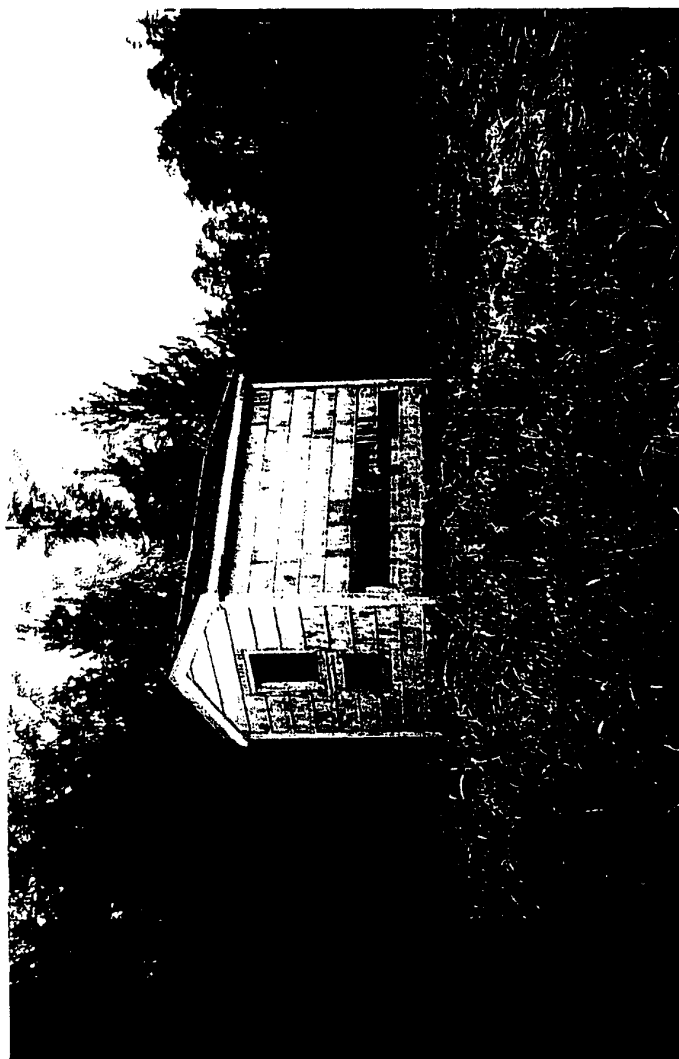
Photograph 24: Middle Marker Facility

The remains of the middle marker facility consist of an 8-foot x 12-foot white wood-frame building (see photograph 24). The building is severely deteriorated and termite infested.

Demolish building after asbestos abatement (see Figure 24-2). Clean up soil from dripline to 15 feet from the perimeter, to a depth of 1 foot. Stock excavated soil in designated central location. Perform confirmation sampling of surrounding soil to ensure that the soil remaining after the remedial action is below the cleanup level for lead.

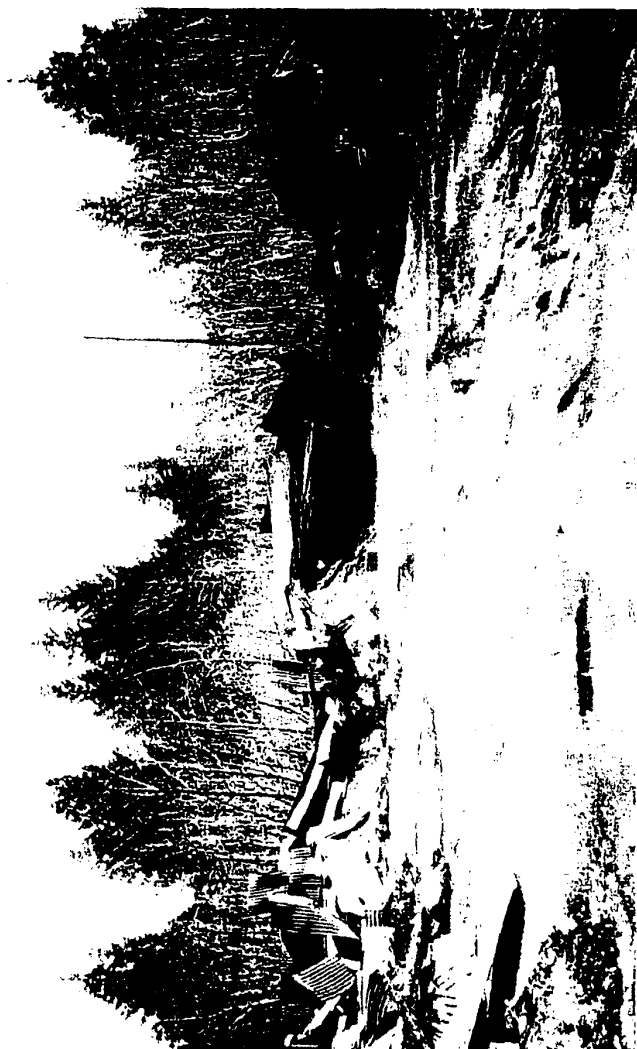
Photograph 37: Sand Shed/Asphalt Plant

The remains of the FAA metal sand shed consist of charred wood debris, metal, and remnants of a sand pile (see photograph 37). Sand was imported by the FAA and used on the runways during icy winter conditions (Ridolfi, 1996). No asphalt plant building currently exists, although a layer of tar covers the surface of the ground around the former site of the sand shed. Several 55-gallon barrels were observed resting on the ground, and partially buried 55-gallon barrels were observed around the north and south perimeter of the area leveled for the sand shed/asphalt plant. A 110-foot x 300-foot area west of the sand shed appeared to be a zone of fill material.

Remove and stockpile for salvage all corrugated metal. Consolidate sand into center of area. Remove contaminated soil to a depth of 1 foot from a 20-foot swatch (see Figure 37-2). Stockpile excavated soils. Perform confirmation sampling of soil to ensure that soil remaining after the remedial action is below the cleanup level for lead.
